TECHNICAL REPORT CERC-90-7

# KING HARBOR, REDONDO BEACH, CALIFORNIA, BREAKWATER STABILITY STUDY

## Hydraulic Model Investigation

Coastal Engineering Research Center

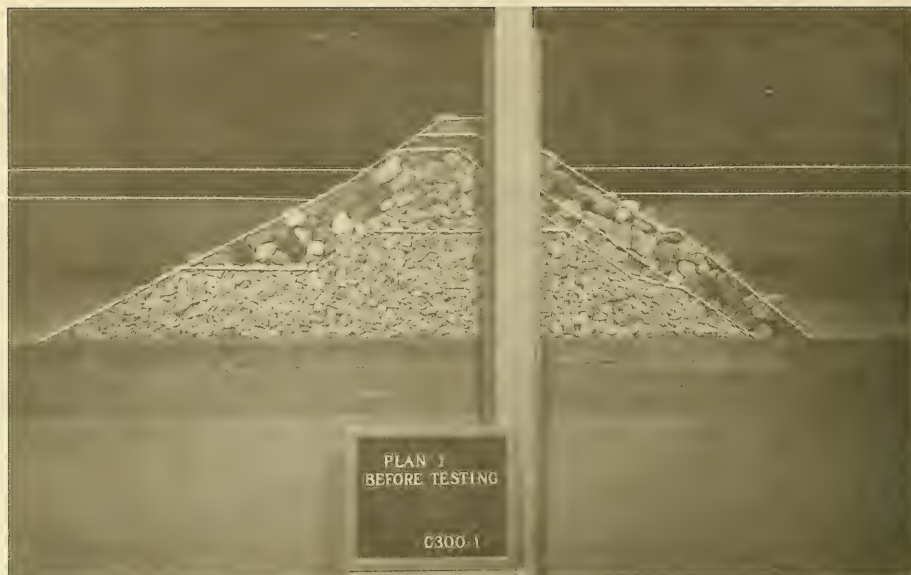
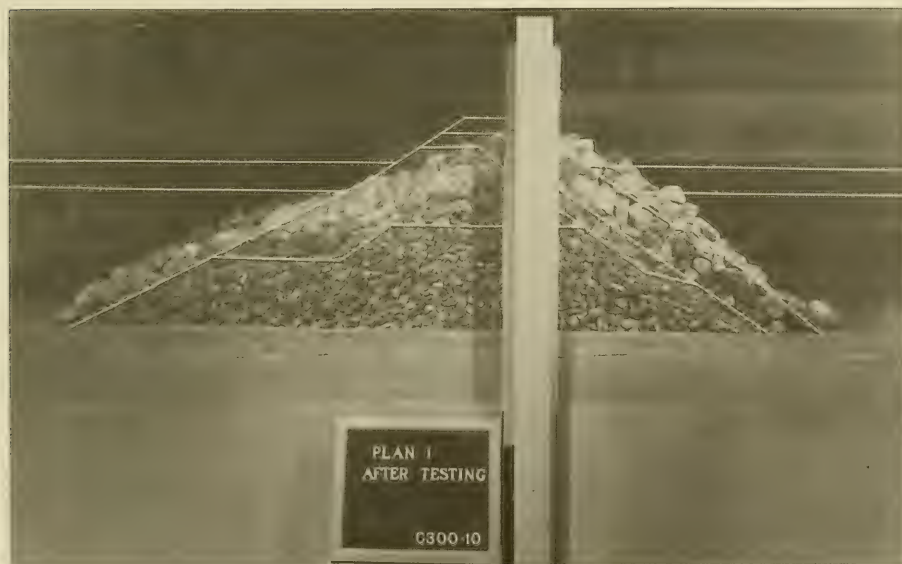
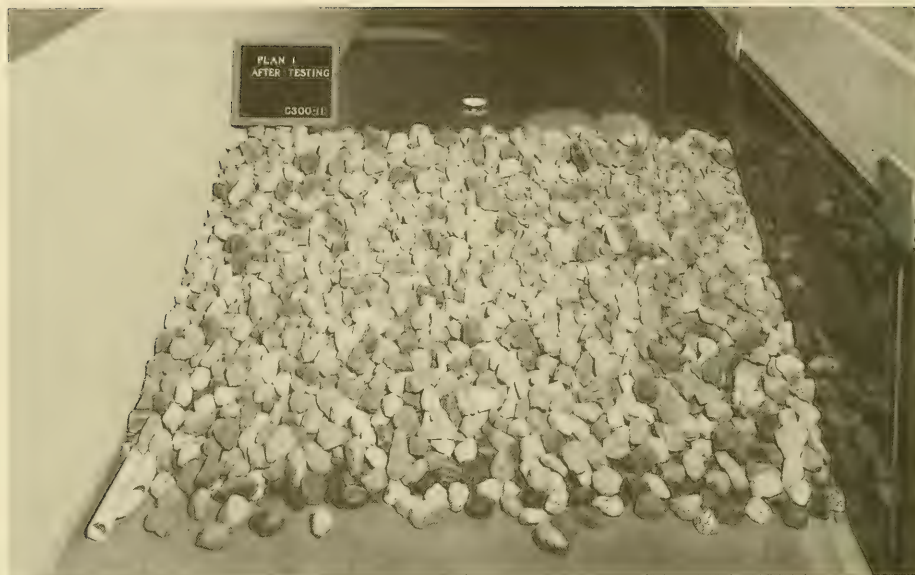
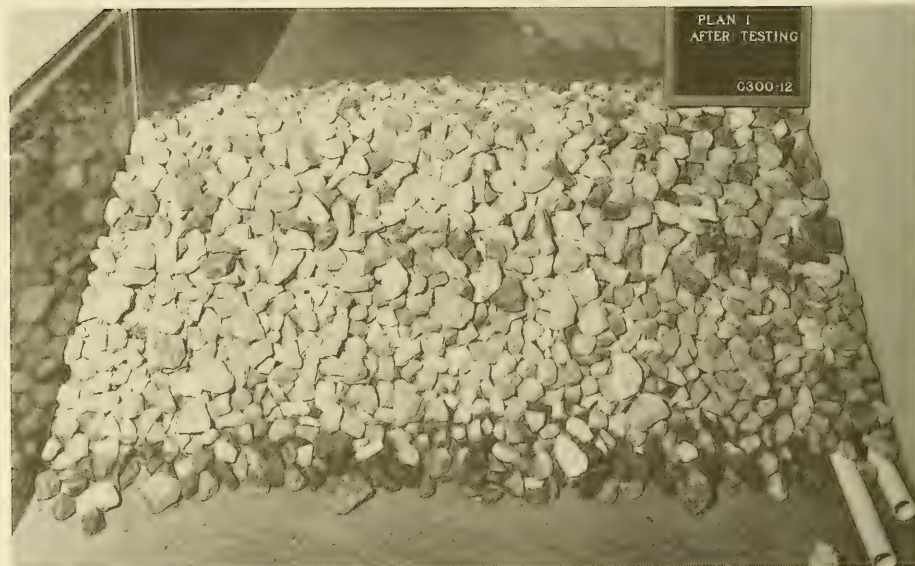
Photo 1. Plan 1, before testing, side view

Photo 2. Plan 1, before testing, sea-side view

Photo 3. Plan 1, before testing, harbor-side view

Photo 4. Plan 1, after testing, side view

Photo 5. Plan 1, after testing, sea-side view

Photo 6. Plan 1, after testing, harbor-side view

23. Plan 1 (Figure 4, Photos 1-6), proposed by SPL, consisted of raising the crest elevation to +20 ft mllw by adding one layer of 11- to 19-ton stone ("A" Stone) to the existing crest, adding two layers of "A" Stone to the harbor side slope from -10 ft mllw to the crest, and placing 3- to 8-ton stone ("A-2" Stone) to -10 ft mllw from the base of the breakwater on the harbor side to form a toe buttress. Placement of armor units on the harbor side at King Harbor is more economical because shallower water depths result in less armor stone required and armor stone placement by ocean-borne construction equipment is protected by the breakwater.

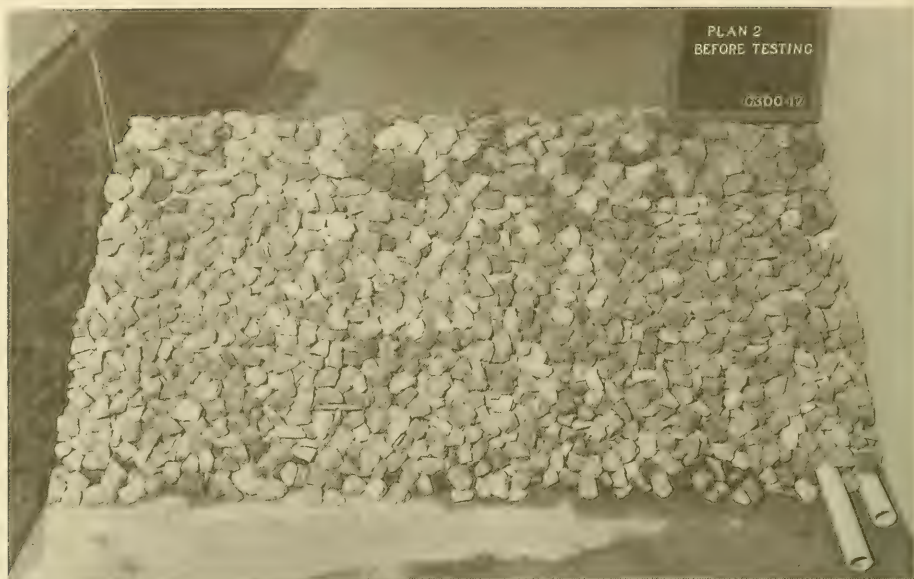
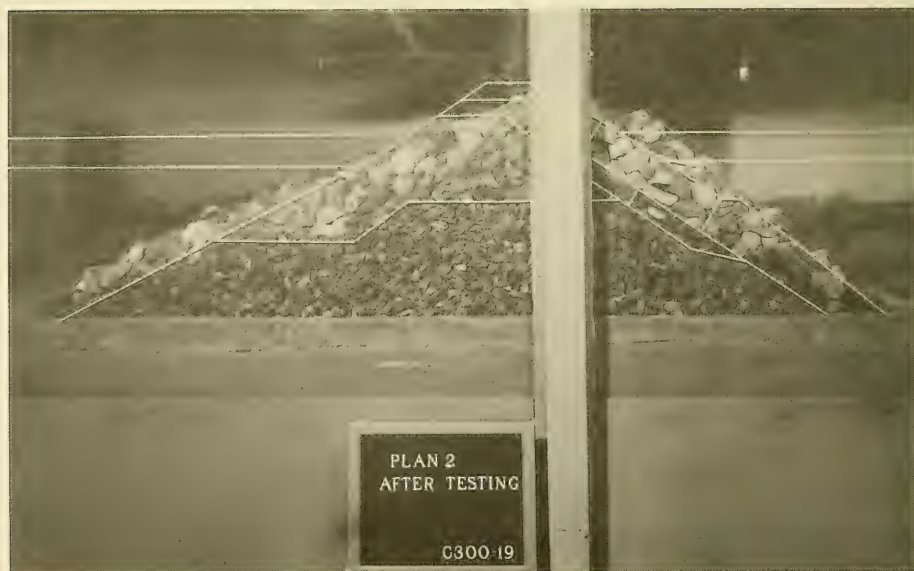
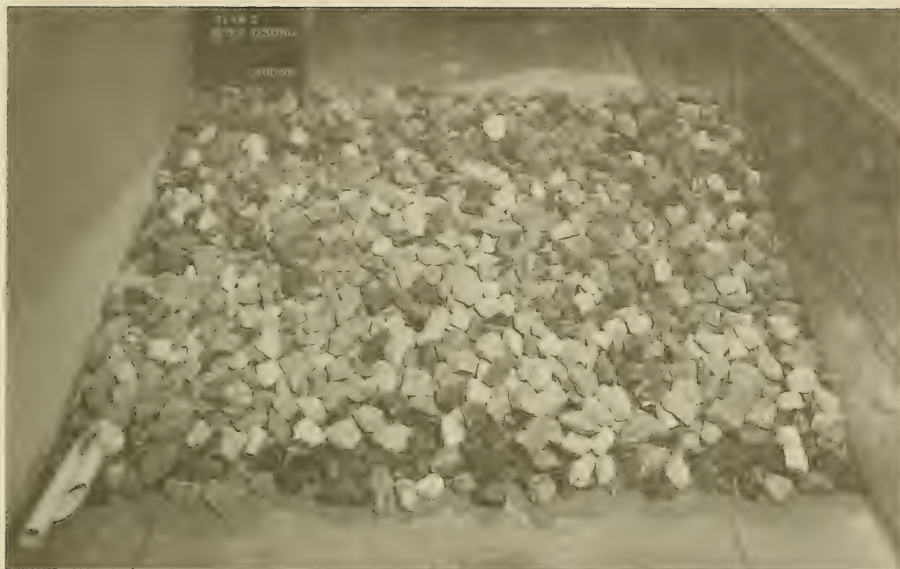
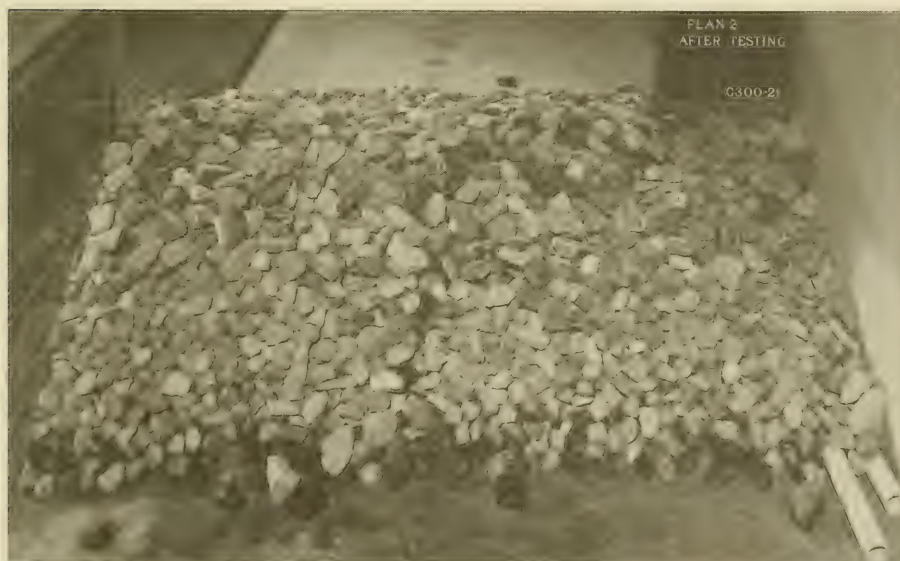
Photo 7. Plan 2, before testing, side view

Photo 8. Plan 2, before testing, sea-side view

Photo 9. Plan 2, before testing, harbor-side view

Photo 10. Plan 2, after testing, side view

Photo 11. Plan 2, after testing, sea-side view

Photo 12. Plan 2, after testing, harbor-side view

27. Plan 2 consisted of the same geometric cross section as Plan 1, but 6- to 11-ton armor stone ("A-1" Stone) was placed from +10 ft mllw to -10 ft mllw, with "A" Stone placed from +10 ft mllw to the crown on the harbor side (Figure 8, Photos 7-12). "A-1" Stone was chosen by SPL as the most economical armor size to replace the larger armor units. The toe buttress was composed of "A-2" Stone, identical to Plan 1.

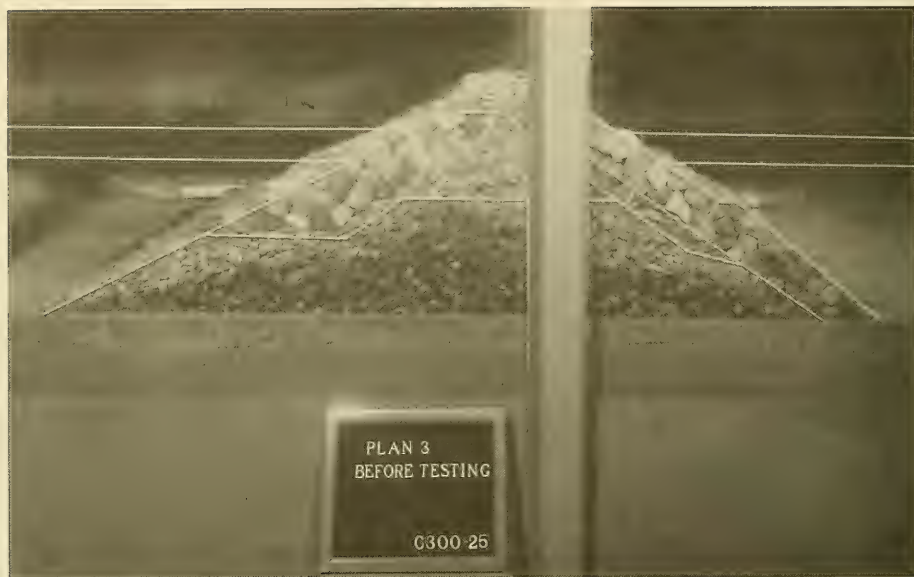
Photo 13. Plan 3, before testing, side view

31. Results from Plan 2 indicated that the "A-1" Stone was stable for all waves if placed on the middle section of the harbor side; "A" Stone in the upper section was stable for  $(H_{mo})_i < 22$  ft; and stability tests with smaller armor stone placed in the upper section might be stable. Plan 3 (Figure 13, Photos 13-18) consisted of the same geometry as Plan 1, except "A-1" Stone was placed on the harbor-side slope from the breakwater crest to -10 ft mllw. The harbor-side toe buttress remained the same as previous plans.

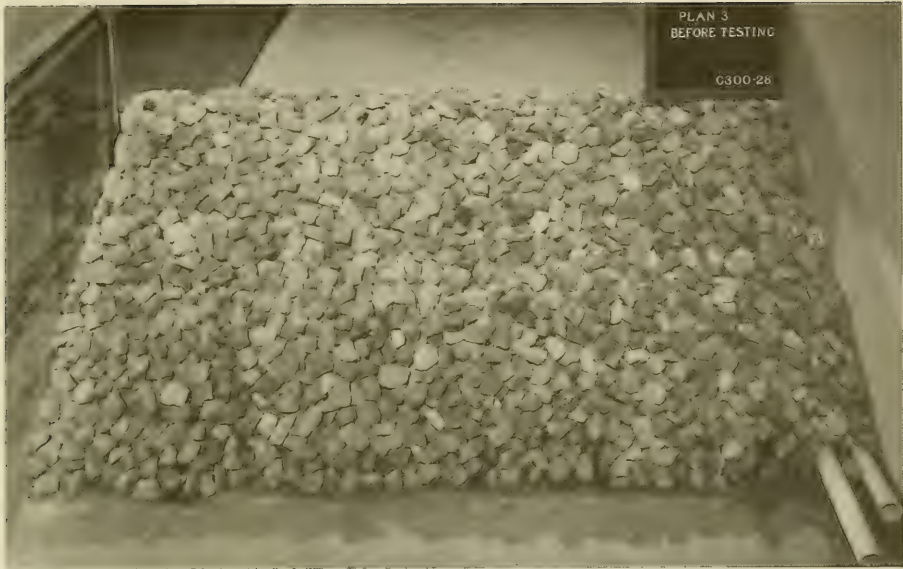
Photo 15. Plan 3, before testing, harbor-side view

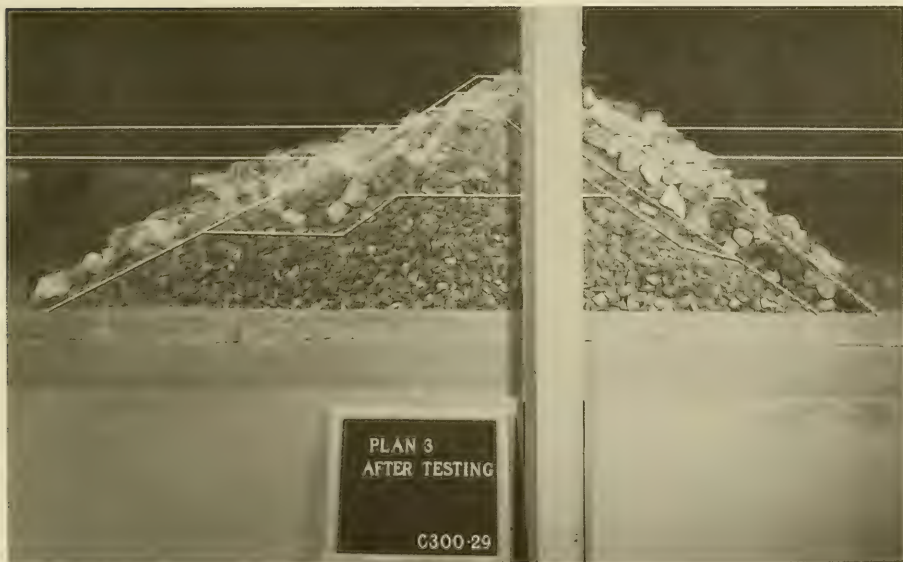
Photo 16. Plan 3, after testing, side view

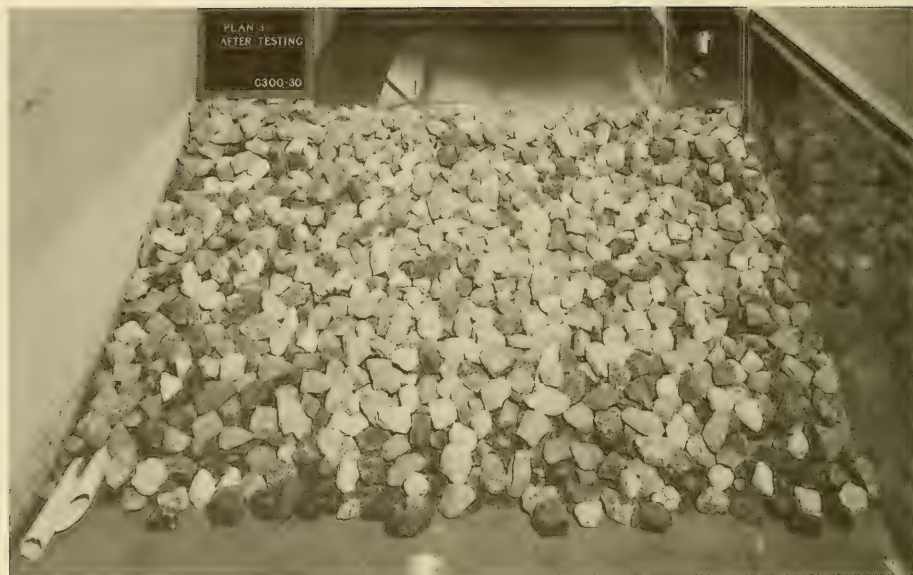
Photo 17. Plan 3, after testing, sea-side view

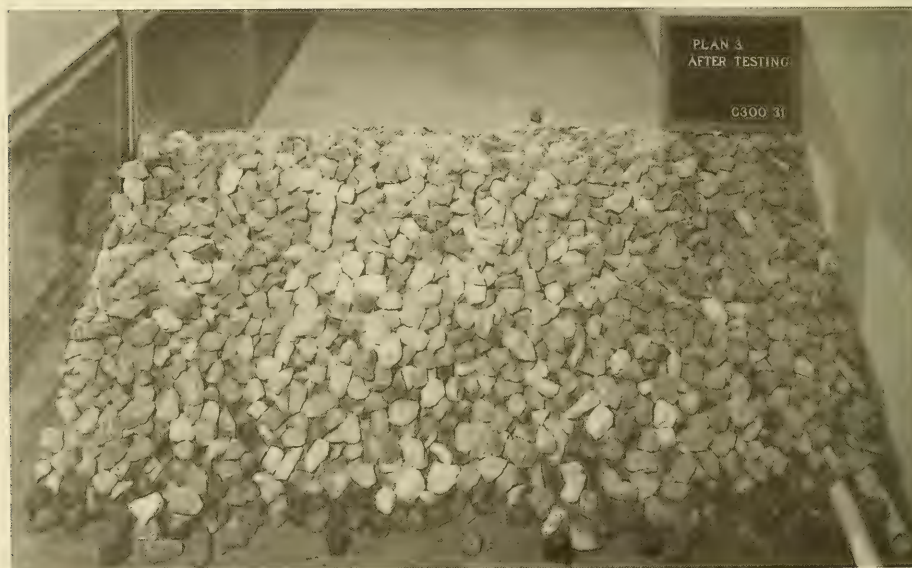
Photo 18. Plan 3, after testing, harbor-side view

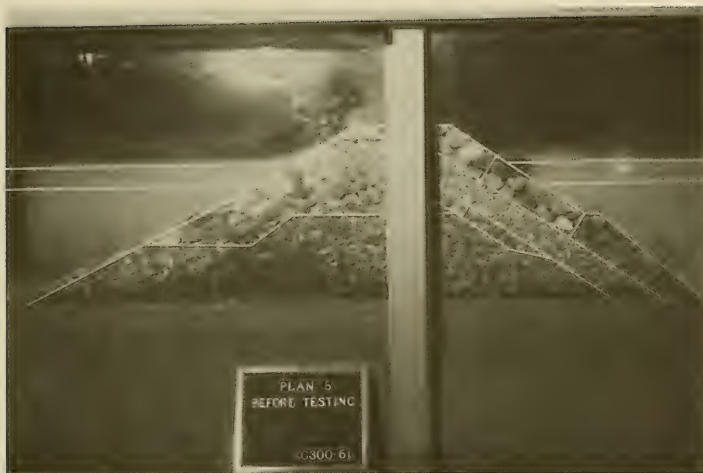
Photo 19. Plan 5, before testing, side view

41. Plan 5 (Figure 22, Photos 19-33) was similar to Plan 4 but consisted of a 10-ft-thick transition layer of 200- to 2,000-lb stone ("T-1" Stone). The armor layers on the harbor side were the same as in Plan 4.

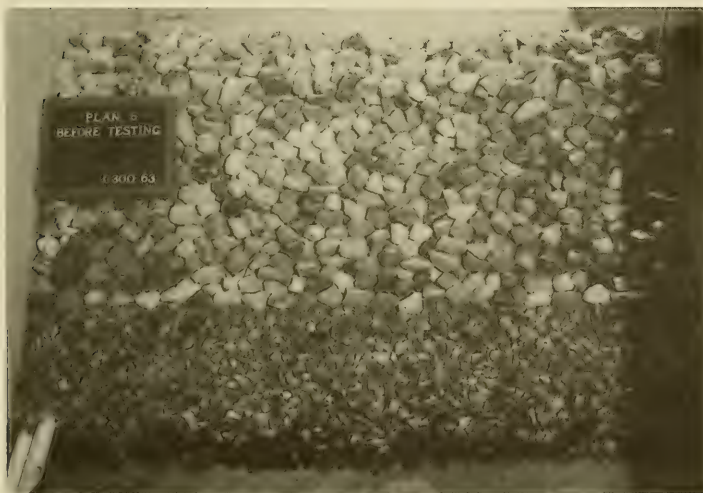
Photo 20. Plan 5, before testing, sea-side view

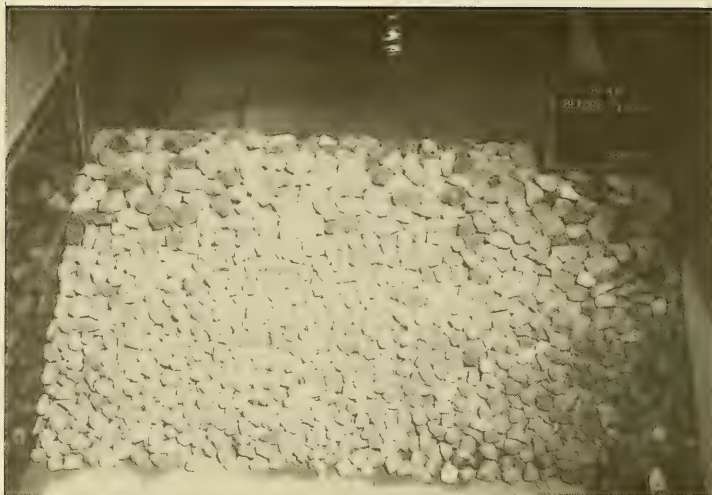
Photo 21. Plan 5, before testing, harbor-side view

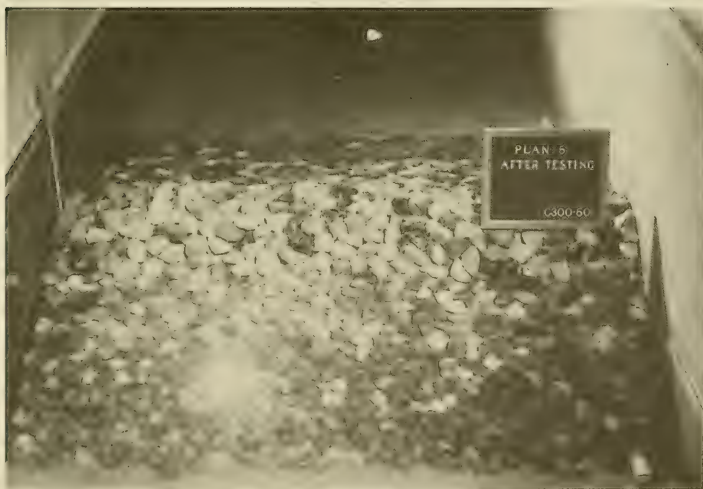
Photo 24. Plan 5, after 13-ft waves, harbor-side view

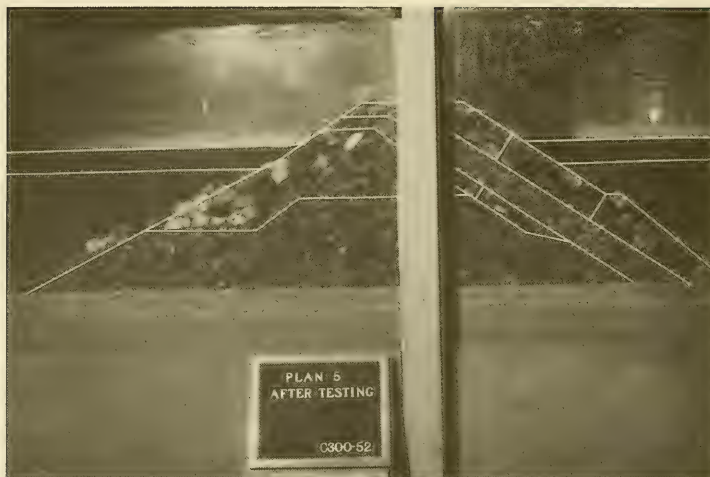
Photo 25. Plan 5, after 16-ft waves, side view

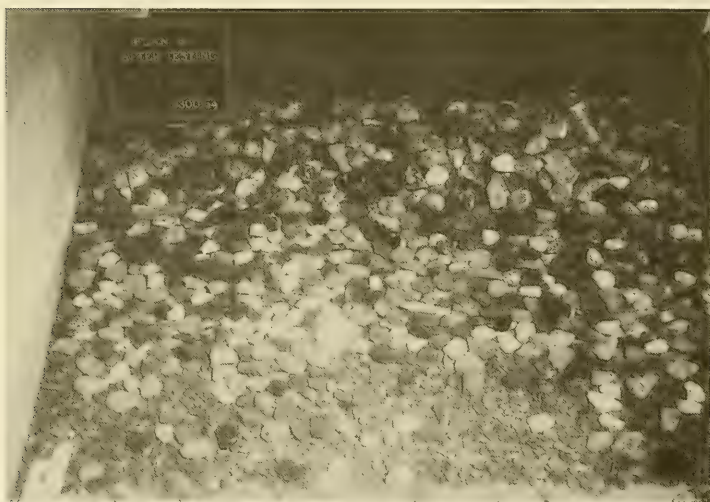
Photo 26. Plan 5, after 16-ft waves, sea-side view

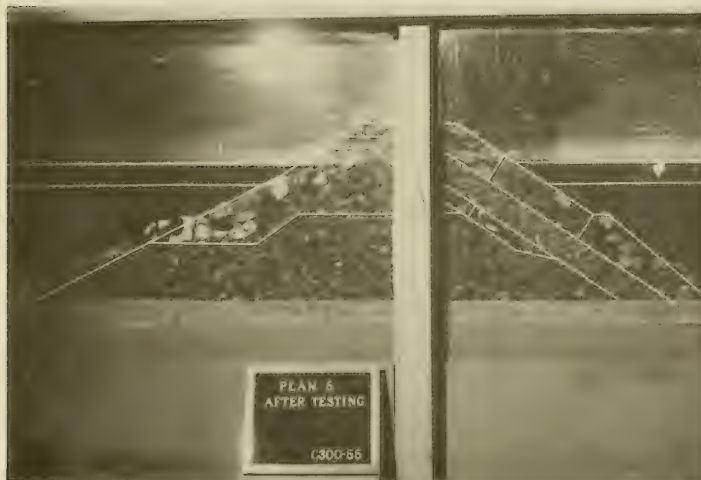
Photo 28. Plan 5, after 20-ft waves, side view

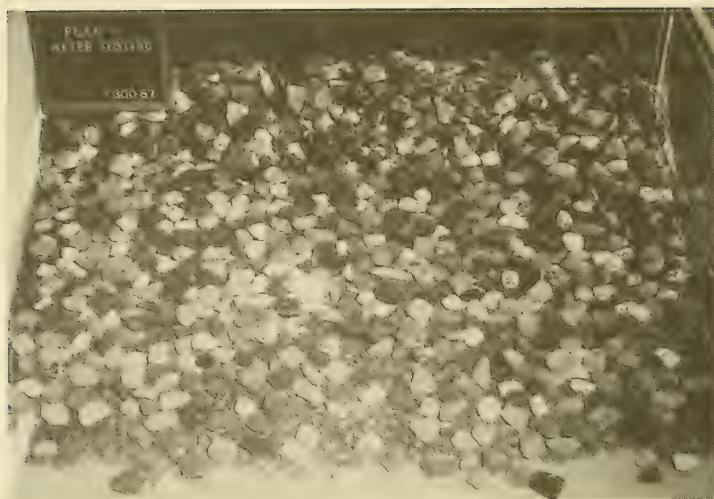
Photo 29. Plan 5, after 20-ft waves, sea-side view

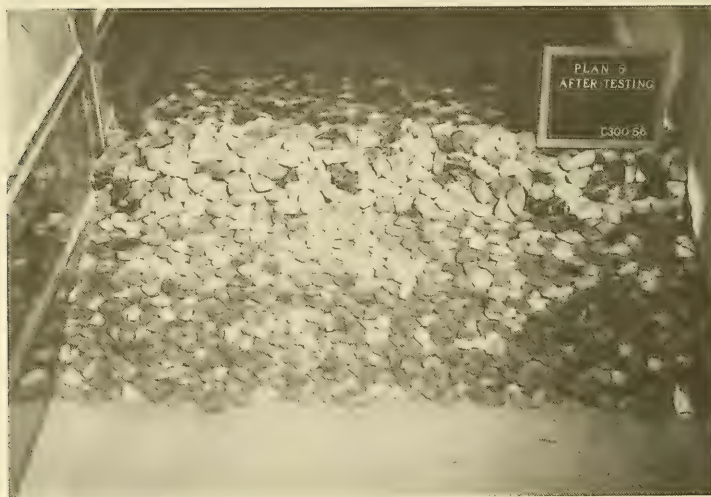
Photo 30. Plan 5, after 20-ft waves, harbor-side view
